## Risk Engineering Services

# Geotechnical Failures

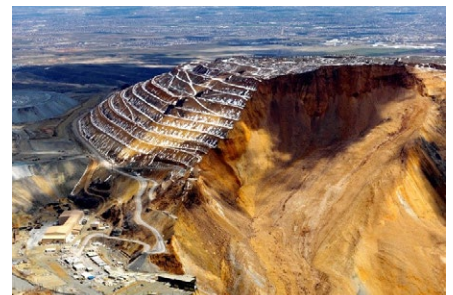
**Above:** Bingham Canyon Manefay Slide. Complete destruction of the highwall, haul road and part of the heavy vehicle workshop.

Manefay Slide. Failure on a fault destroyed high wall, haul road and Heavy Vehicle Workshop followed by a second run out of material which buried and damaged mining equipment at the far side of the pit. No fatalities.

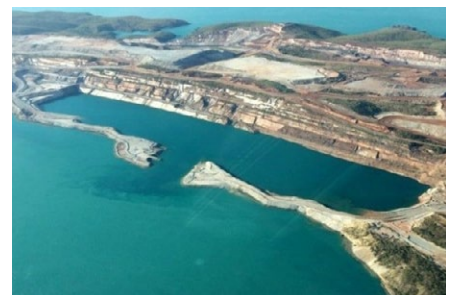
**Below:** The Koolan Island iron ore mine was closed after the seawall collapsed.

Koolan Island main pit seawall failed flooding the open pit following high tides. Around 200 workers were made redundant following the failure, with operation later placed in care and maintenance. USD 64m cost to the insurance market.

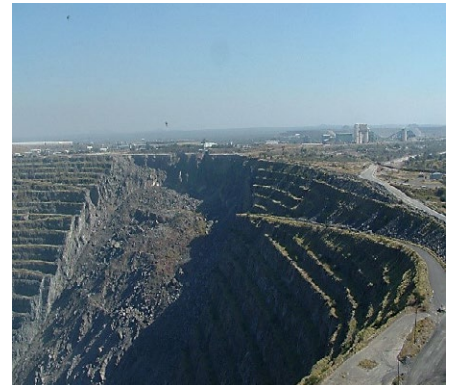
**Above:** Palabora open pit failure. Due to undetected fault structures the wall of the open pit failed following the initiation of the black cave beneath the pit. The failure eventually destroyed the haul road in the neighbouring Foskor Operation.

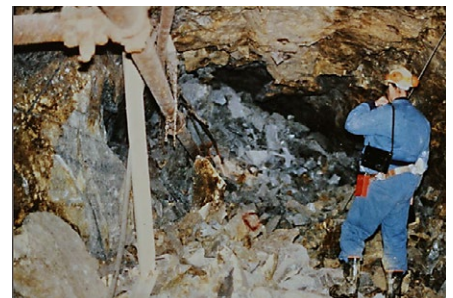
**Below:** The results of a rockburst in an underground mine in brittle rock subjected to very high stresses.
