Identifying and understanding construction risks

# Lessons Learnt in Construction Projects

## Hot work permit Fire at a milling plant

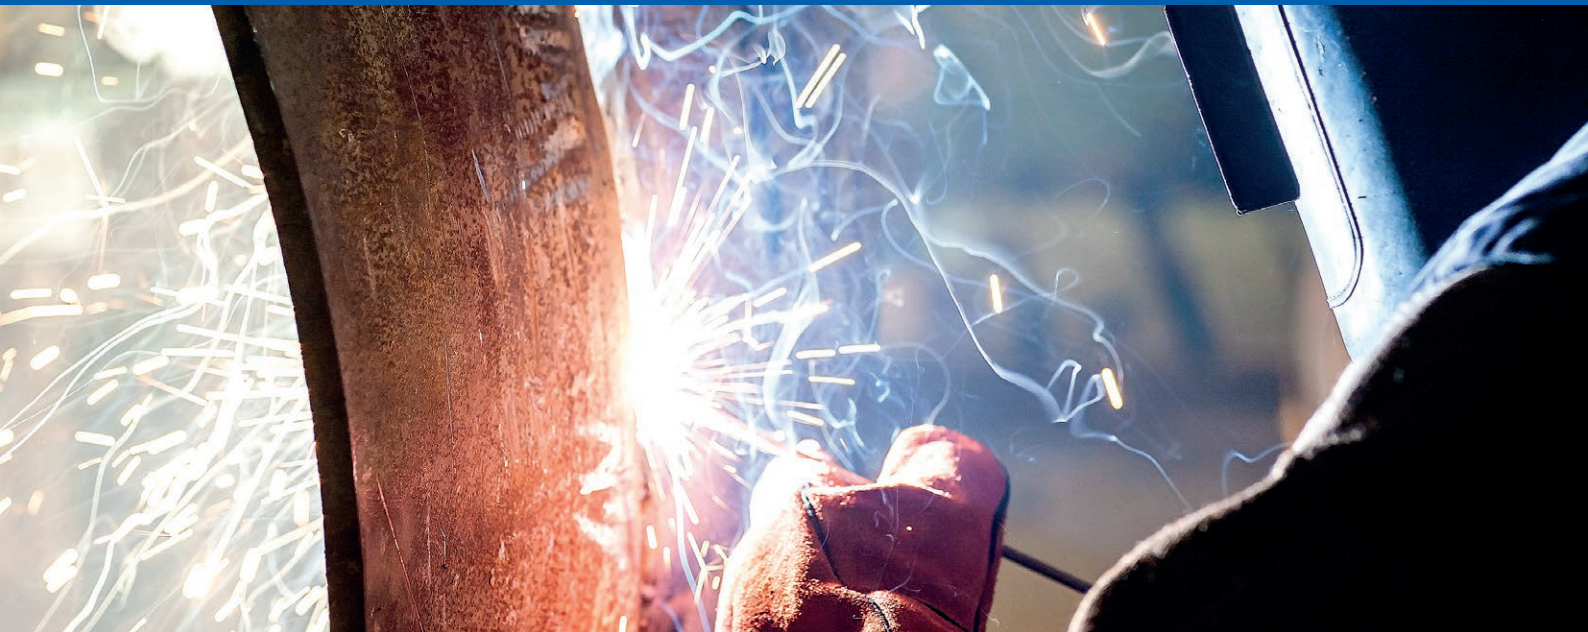
In many cases removal of metal objects, such as bolts, can only be done using an oxy acetylene torch. A contractor needed to remove a bolt inside a mill and an oxy acetylene torch was used to cut out the bolt. Although a hot work permit would need to be issued for any welding, the permits only address the specific area, rather than the hazards associated with the job.

Sparks from the cutting torch ignited a flammable liquid which was spilt nearby. The burning liquid set light to the machinery and the conveyor belts causing the fire to spread throughout the mill liner and plant. This was exacerbated by the chimney effect inherent in the mill design, causing fire and hot fumes to travel up through the system. The fire burned for a number of hours before it was brought under control.

**Delays, damage and costs:** There was major fire damage to the milling equipment, chutes, screens, conveyor belts and auxiliary equipment. The fire caused a shutdown of operations at the milling plant of several weeks.

Hot work permits, although usually company-specific, are more or less similar around the world. The procedure requires that any hot work is properly authorised and carried out under strictly controlled conditions with appropriate risk control safeguards in place. However unless a permit is issued for each and every hot work job, there is a danger that the specific hazards for each job are not identified and controlled. In this case the permit issued was not sufficiently specific.

The procedures laid out in the hot work permit should have required that the workplace would be inspected before the hot work was started to ensure that there were no combustible materials near the work site, that oil spillages were cleaned up and that equipment was protected by non-combustible tarps.

The presence of a fire watch equipped with appropriate fire-fighting equipment would have controlled and limited the spread of the fire.

Fire retardant belts would have inhibited the progress of the fire. Although more expensive, they are readily available.

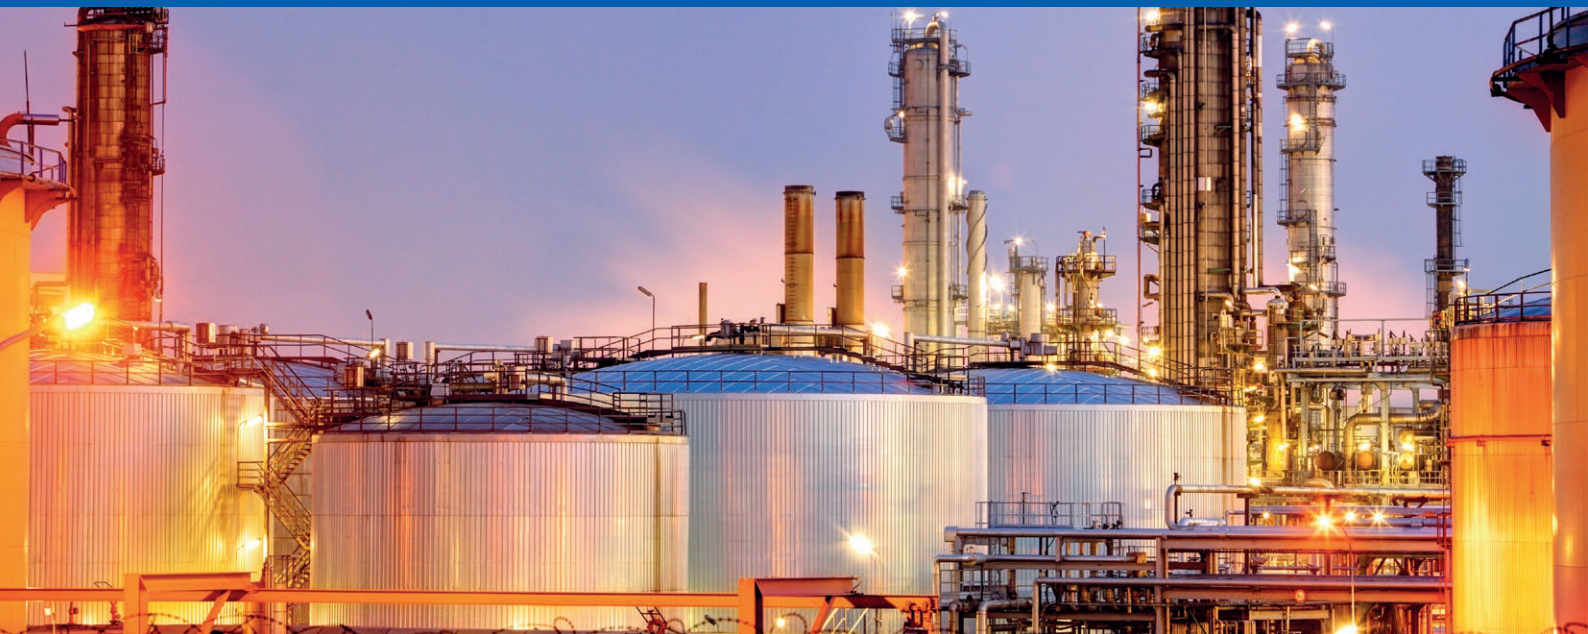
# Hot work permit Gas plant construction fire

All hot work on a gas plant construction site require a permit to work for each specific job due to the presence of combustible materials in the construction area. This typically requires a fire watch to be present during the work and for 30 minutes after completion. Hot work was to be carried out on a compressor package in a utilities area. A hot work permit was issued and the welder started work.

Before the job had been completed a fire broke out on the compressor package. The welder had left the hot welding equipment in the work place to go to lunch. Thinking that it was in a safe location, he covered the equipment with plywood to protect it from the wind and dust.

Although a fire watch was on hand, he also went to lunch with the welder, instead of remaining at the work site for a further 30 minutes, as required by the hot work permit.

Attempts to suppress the fire were only partially successful. The fire was made worse by the amount of combustible materials nearby, including wood and a plastic tarpaulin.

The fire caused damage to electrical cables and equipment at a cost of approximately USD 2 million. However, it could have been far worse but for the rapid intervention by the site fire brigade. If the equipment had been badly damaged, the loss would have been far higher and the project would have been delayed by several months.

Minimising the presence of combustible materials at the work site is very important when carrying out hot work, before, during and after the work. Although smoking was not a factor in this loss, nevertheless this is a common source of ignition and should not be allowed in construction areas.

The fire watch needs to understand his responsibilities and the potential hazards. It is a crucial role that requires competence and good training. Our experience is that the Fire Watch can easily be distracted from this critical task if not appropriately educated and adequately trained.

Tarpaulins are frequently used in construction sites for equipment protection and to provide wind protection during welding. The use of fire retardant tarpaulins is best practice and should always be used on construction sites.

It is best practice to post signs around vulnerable areas on site, for example around dry cooling towers, within electrical buildings under construction, and around critical equipment to ensure that any hot work carried out is appropriately controlled and managed.

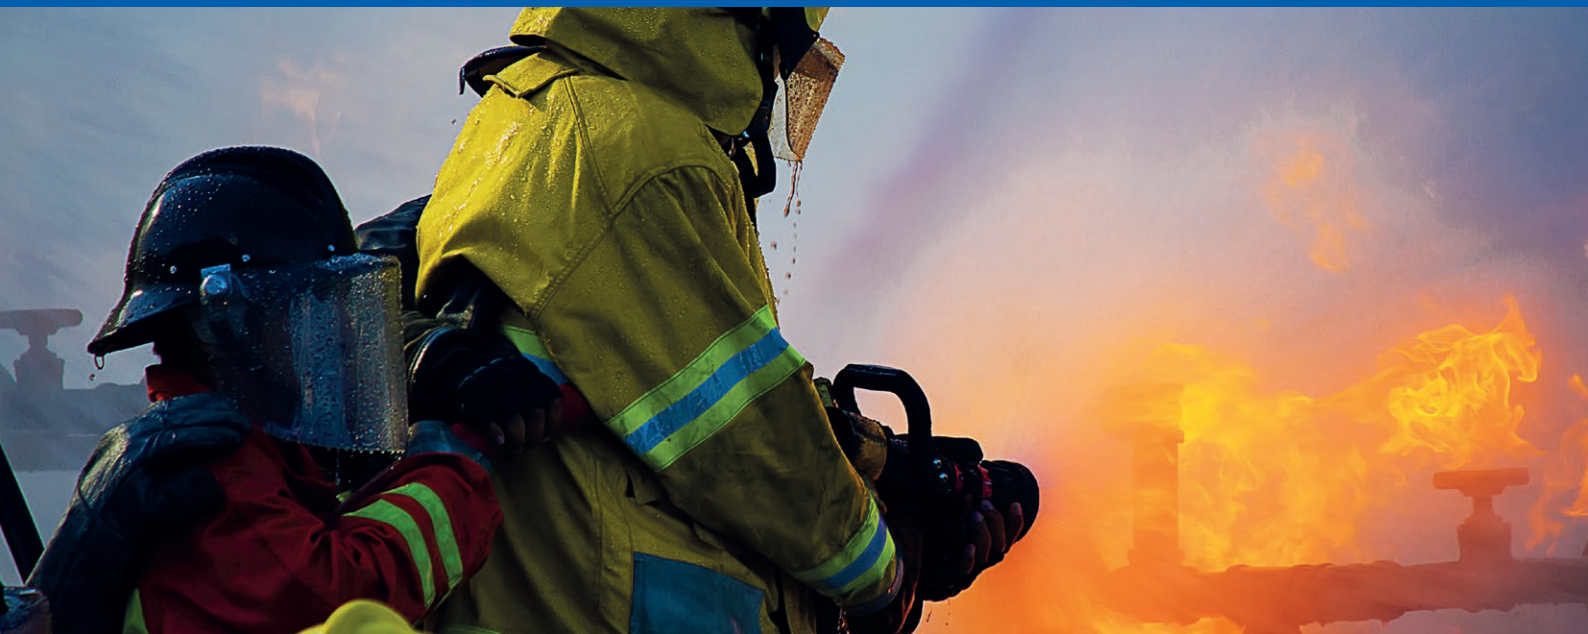
## Petrochemical plant construction fire

A fire broke out during the erection of a hydrocarbon storage tank. It engulfed the scaffolding and tarpaulins, although fortunately, the fire was extinguished before it was able to affect the integrity of the tank.

Welding work had been carried out on the shell of a tank. At the end of the working day, after the contractors had finished work, a fire started burning through canvas tarpaulins used for wind protection. This was caused by hot halogen bulbs, used to provide lighting for the welders, which made contact with the combustible tarpaulins. Combustible electrical cables caused the fire to spread to the wooden scaffolding boards surrounding the tank.

All available local fire extinguishers had been used up in the initial, unsuccessful, attempt to fight the fire. Unfortunately there was a delay before mutual fire-fighting assistance could arrive as there was a lack of knowledge and understanding of procedures and protocols.

Neighboring plants had agreed to provide mutual aid, which is common practice. However, in this case, there was a breakdown in communication about the compatibility of the water hose connectors, which caused a further delay in accessing the available water supply. This caused the fire to burn for a prolonged period until it was eventually extinguished.

The fire burned for much longer than necessary due to the delays caused by lack of emergency response planning, communication and fire-fighting equipment management. It was fortunate that there was no major damage to the tank and the construction site.

Ensuring that staff and contractors are prepared is key. They need to know the emergency response plans, protocols and procedures, which differ from one construction site to another. These need to be tested through formal drills, using various scenarios, involving contractors and security.

An important function of emergency response drills is to ensure that fire-fighting equipment and resources function as intended.

Regular reviews of internal and external support capability is necessary to verify that site water supply systems are compatible with fire response equipment.

Common ignition sources should be avoided, for example exposed halogen bulbs are a frequent ignition source, as is hot welding equipment and smoking. The use of combustible materials should be avoided or minimised. Best practice is to use non-combustible lighting cables, non-combustible tarpaulins and aluminium scaffold boards.
